Missouri River BSNP Project Maintenance Omaha District

Missouri River Navigators Meeting
February 10, 2015

Matt Krajewski
Missouri River Project Office, Omaha NE

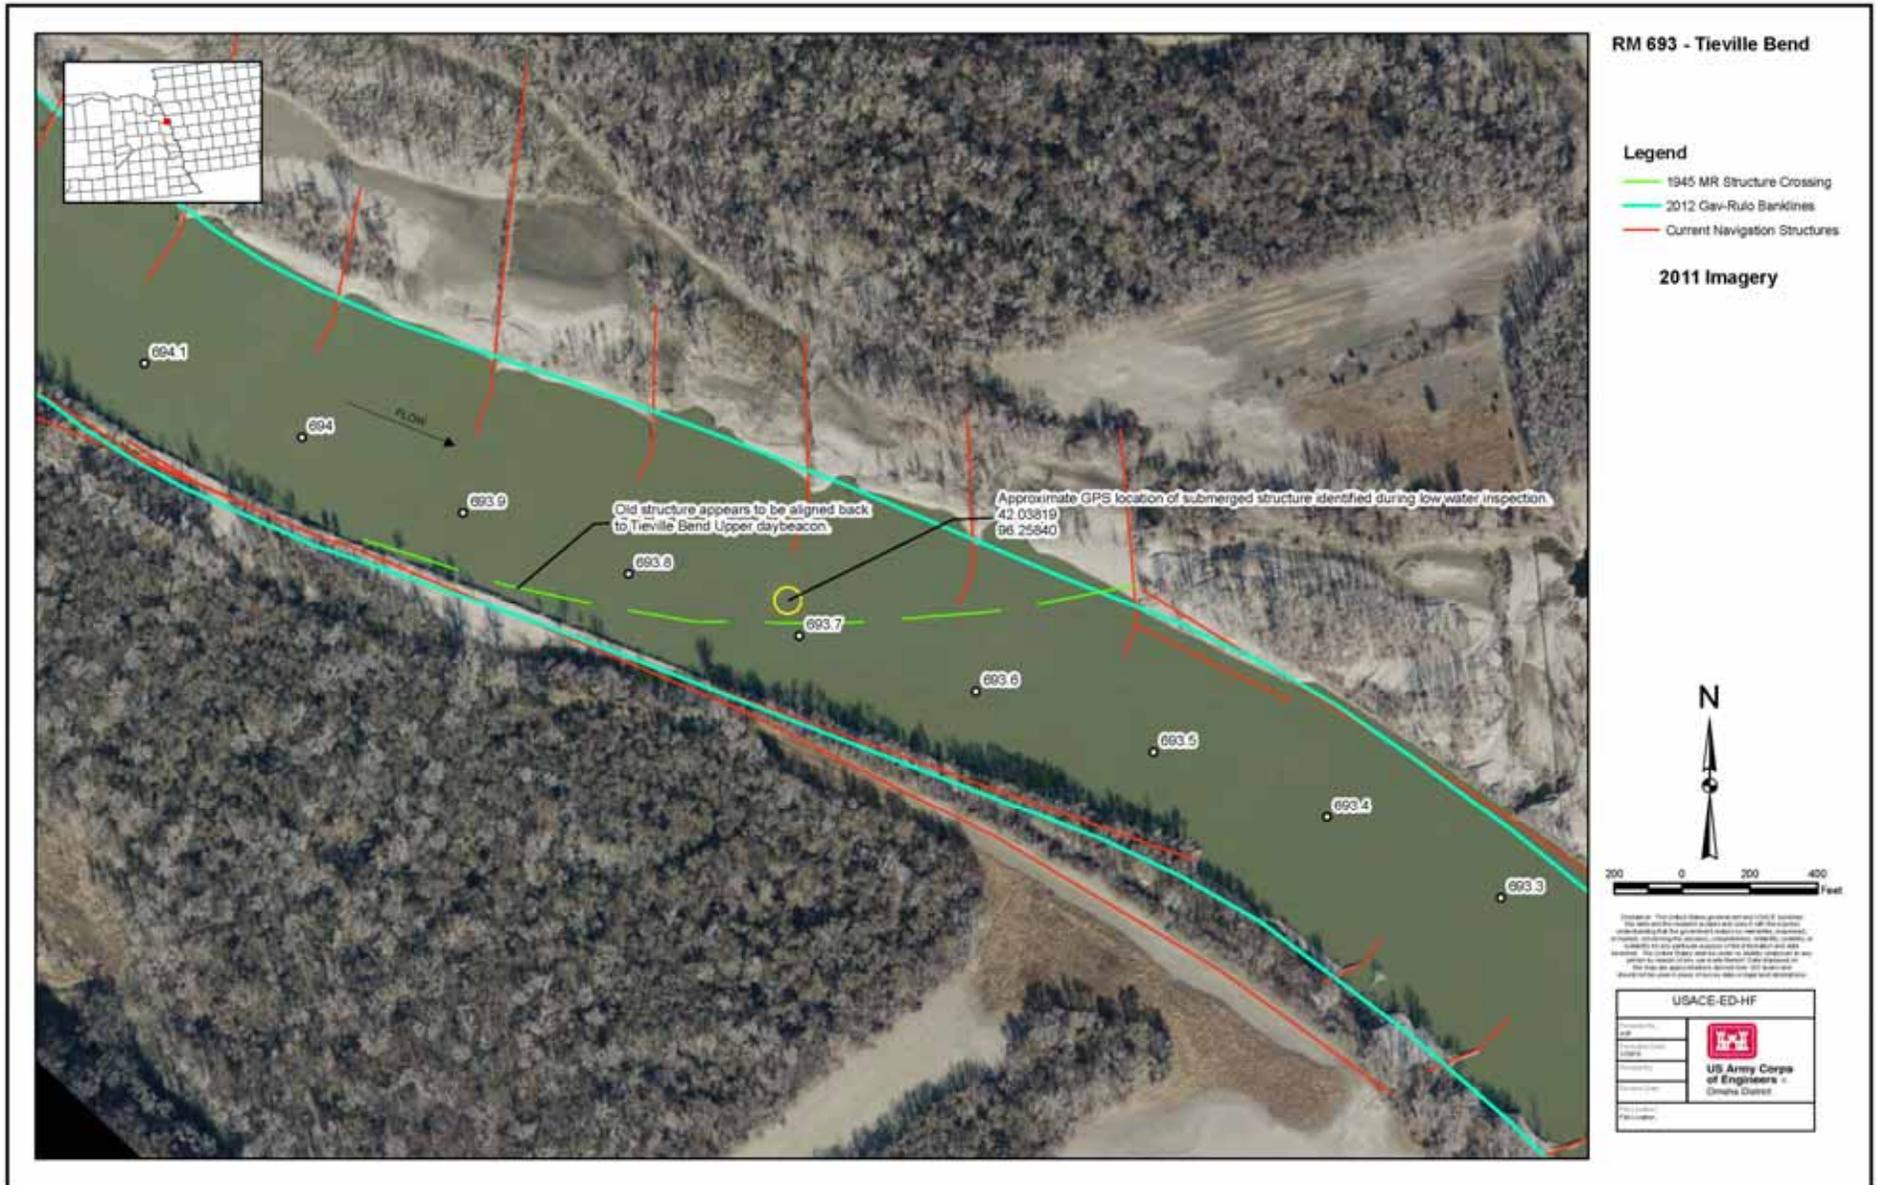
Example Near Decatur

- Missouri River channelization took place over many decades. Final alignment from the Boyer River (RM 635) upstream to Sioux City (RM 735) not in place until after World War II.
- Structures along earlier alignment(s) were manually degraded when the final alignment was established in the 1950's. Continued river degradation may expose the historic structures.
- Minimal records on location/depth of historic structures
- Two spots of insufficient channel depth noted in the navigation channel near Decatur during the Dec 2013 low water inspection.

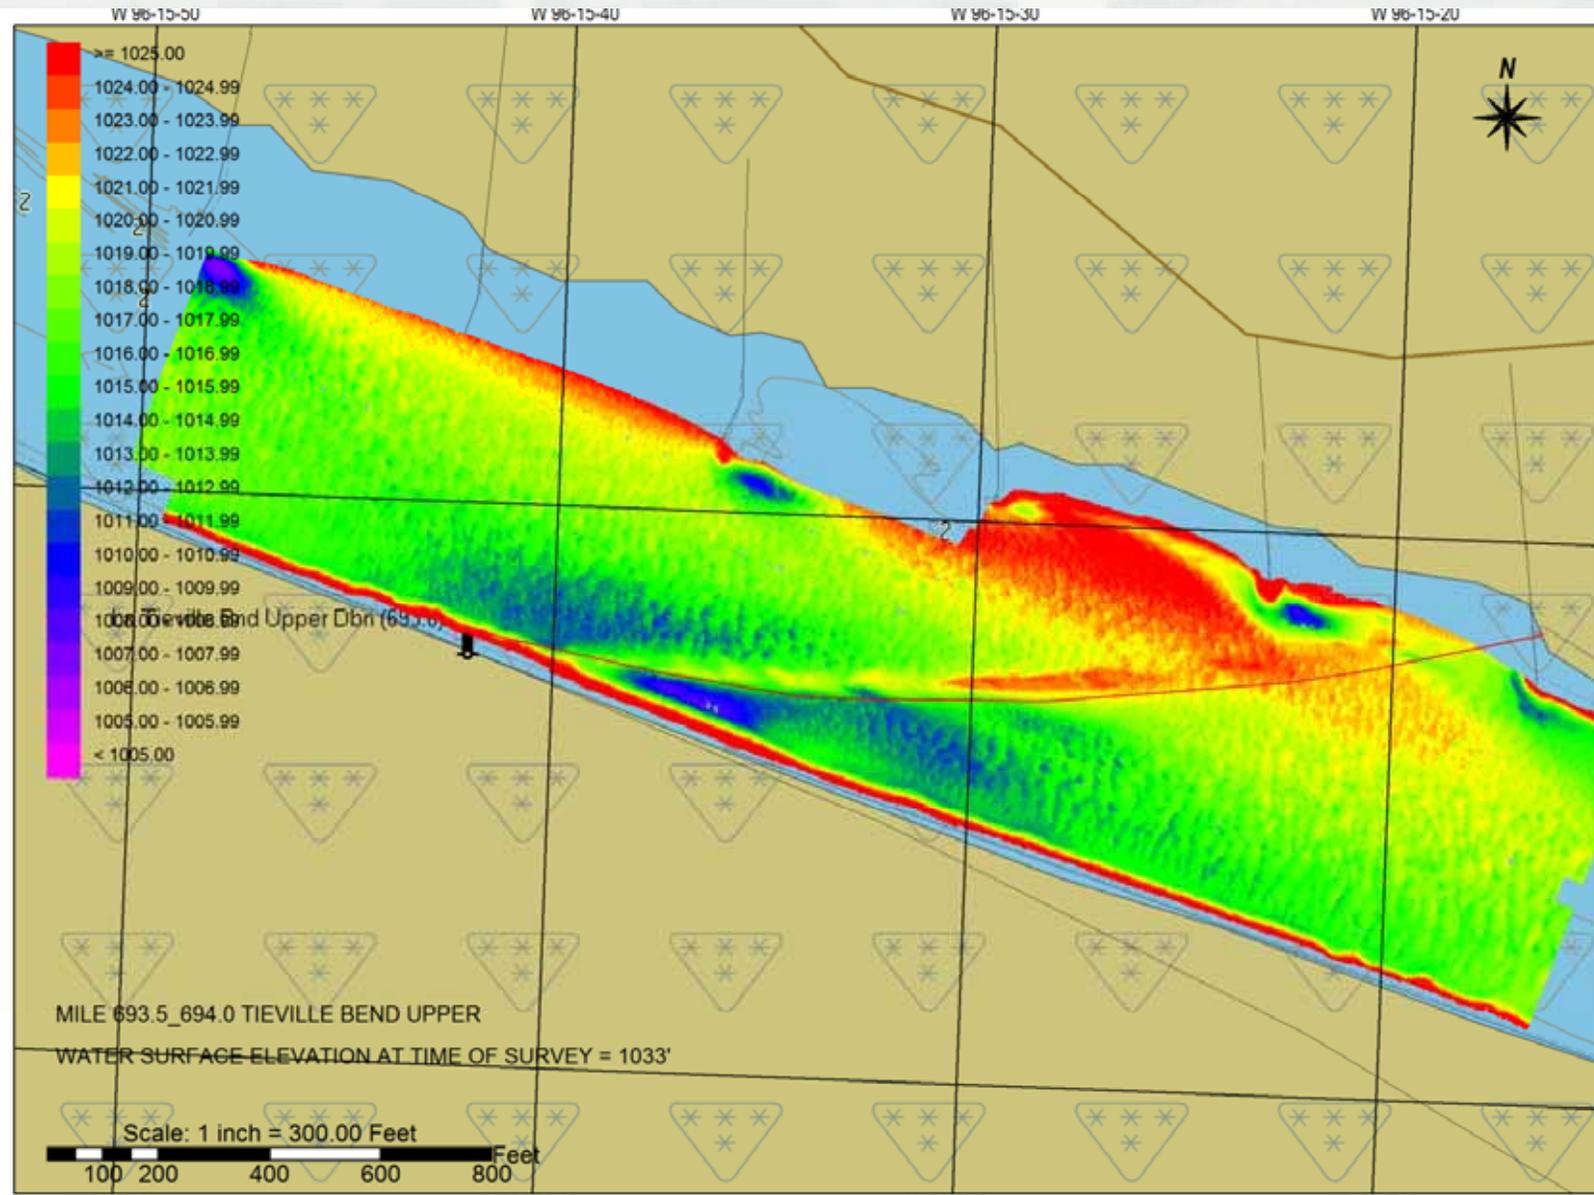
ERDC Survey Results

- Reviewed old plans, identified about 30 possible sites
- ERDC conducted multibeam and sonar survey in early spring 2014
- Structures found in survey degraded by Project Office work crew in 2014
- Work in five bends and about 2250 tons stone, piling removed, 2 months effort

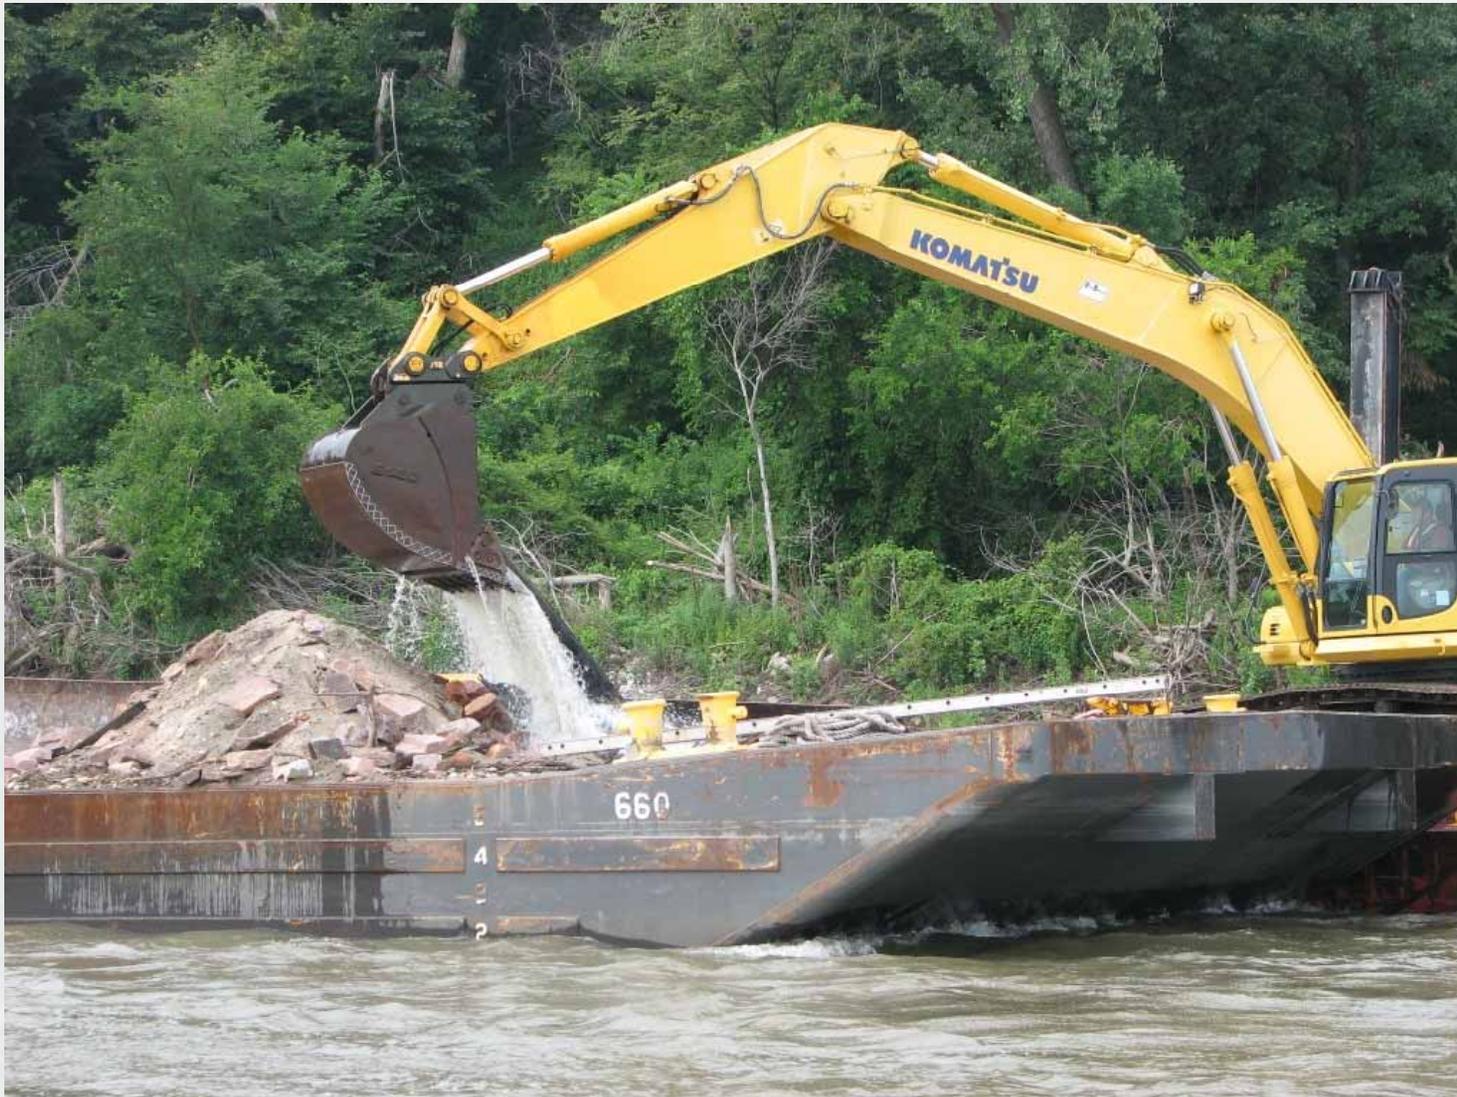
Material Removed From Decommissioned Structures

July 2014

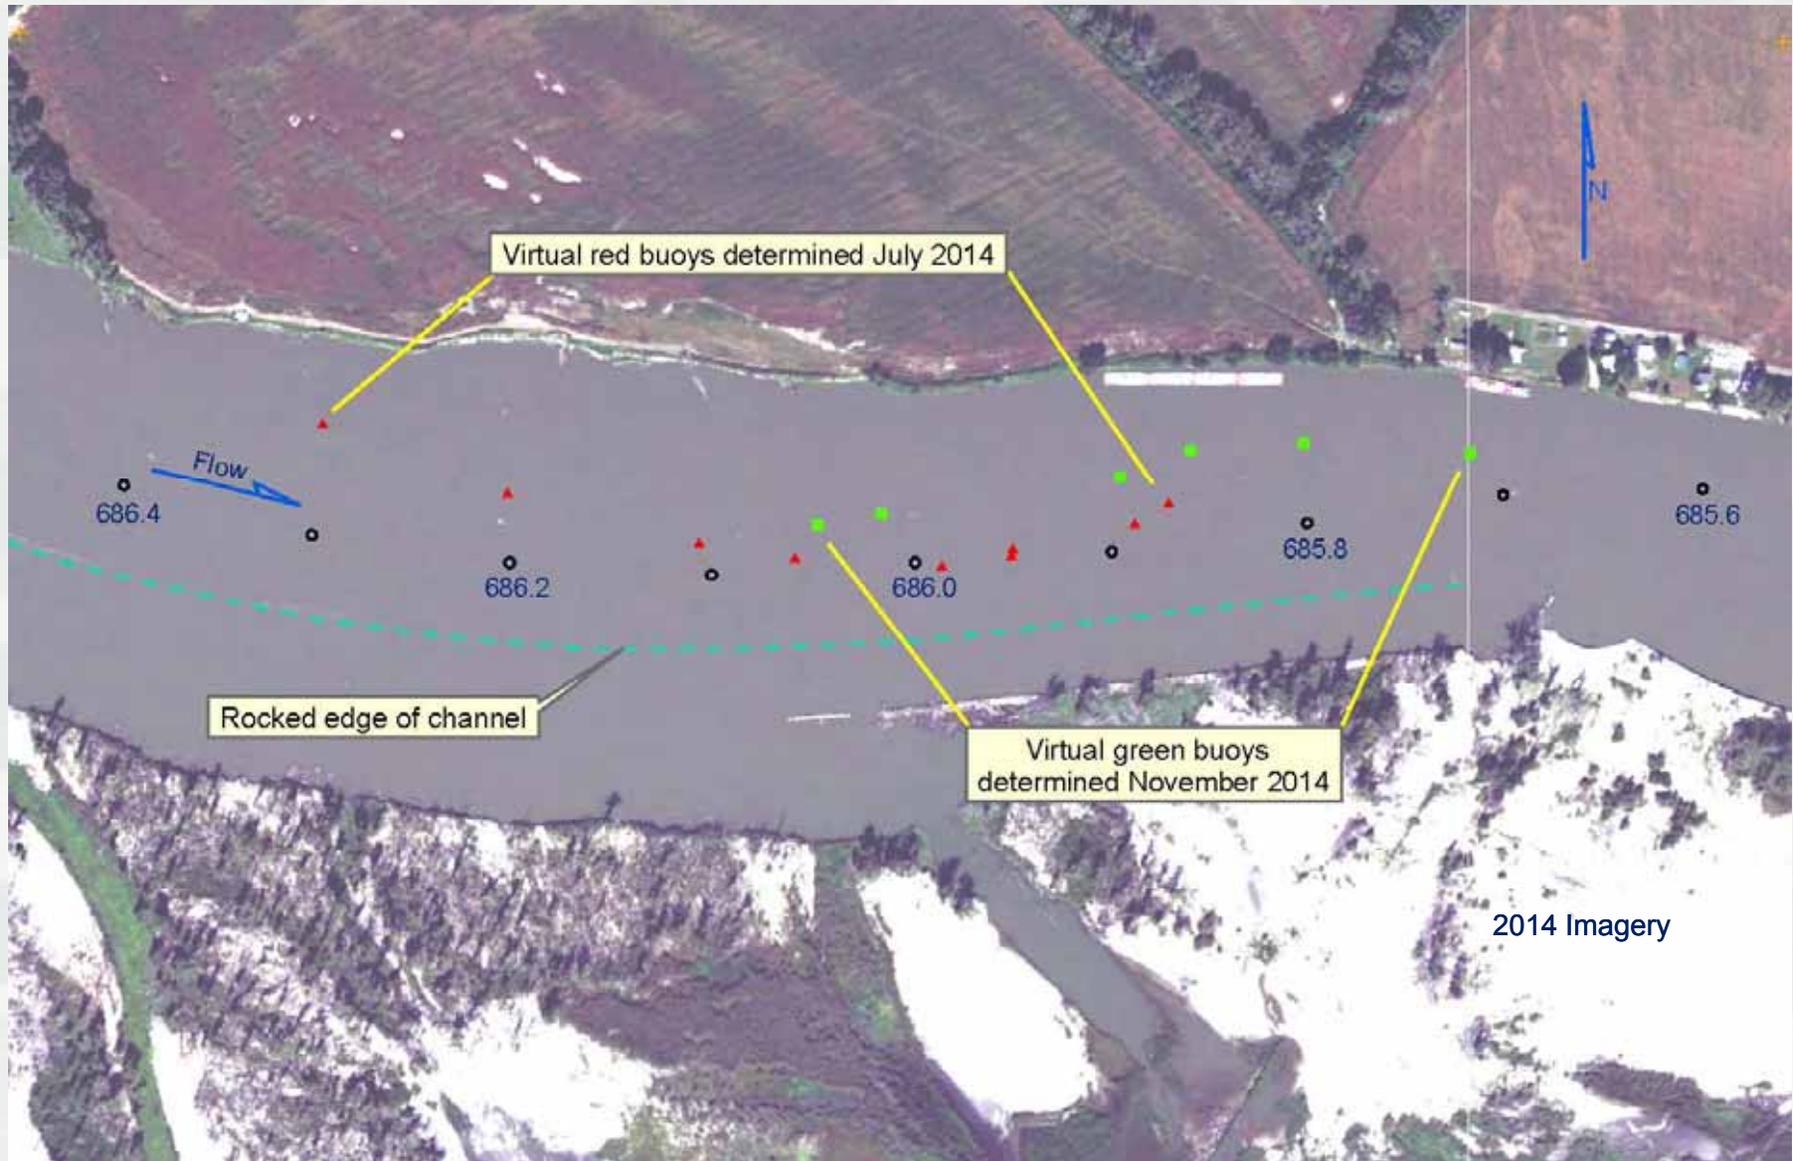
Lower Decatur Bend Channel Efforts

- Decommissioned structure degrades
- Lower Decatur Bend placed 10,800 tons to address shoal. Also conducted several channel recon missions, defined virtual buoys, conducting modeling to refine design, more work anticipated in 2015
- Total rock placed about 15,000 tons by MRPO
- By Contract (Approximate Totals)
 - ▶ High Priority post-flood repairs below Boyer Bend: 68,000 tons. Focused on Deroin Bend.
 - ▶ Remaining Sites: 71,000 tons.

- ▶ Developing work plan from Dec low water inspection notes
- ▶ Anticipate placement of 30,000 to 40,000 tons of maintenance rock
- ▶ Lower Decatur bend priority

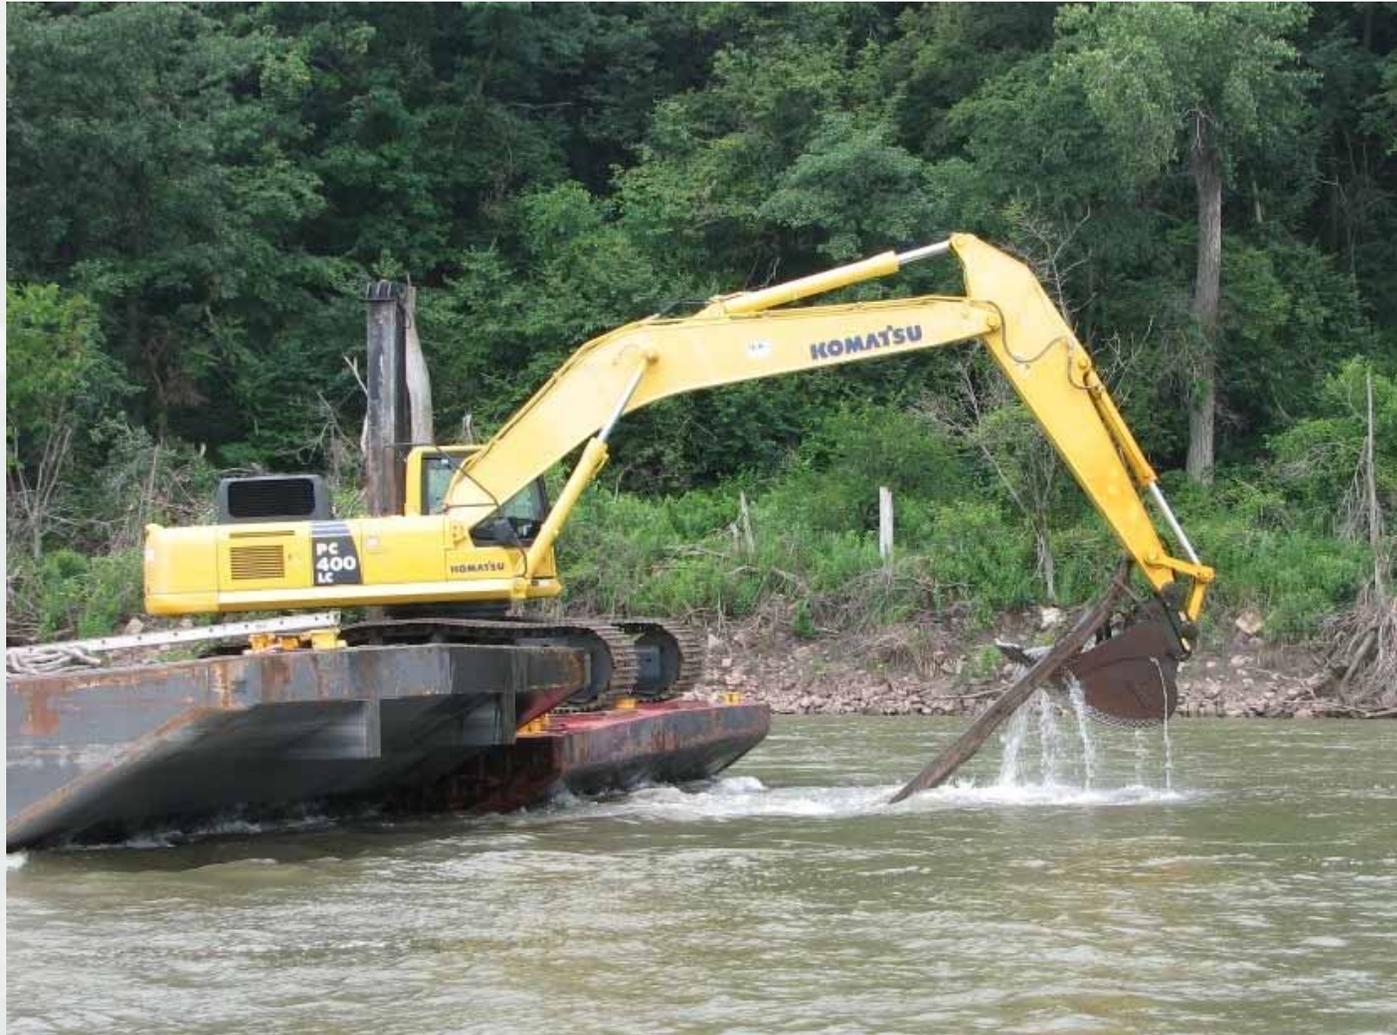
Removing Old Timber Pile from Decommissioned Structure

July 2014

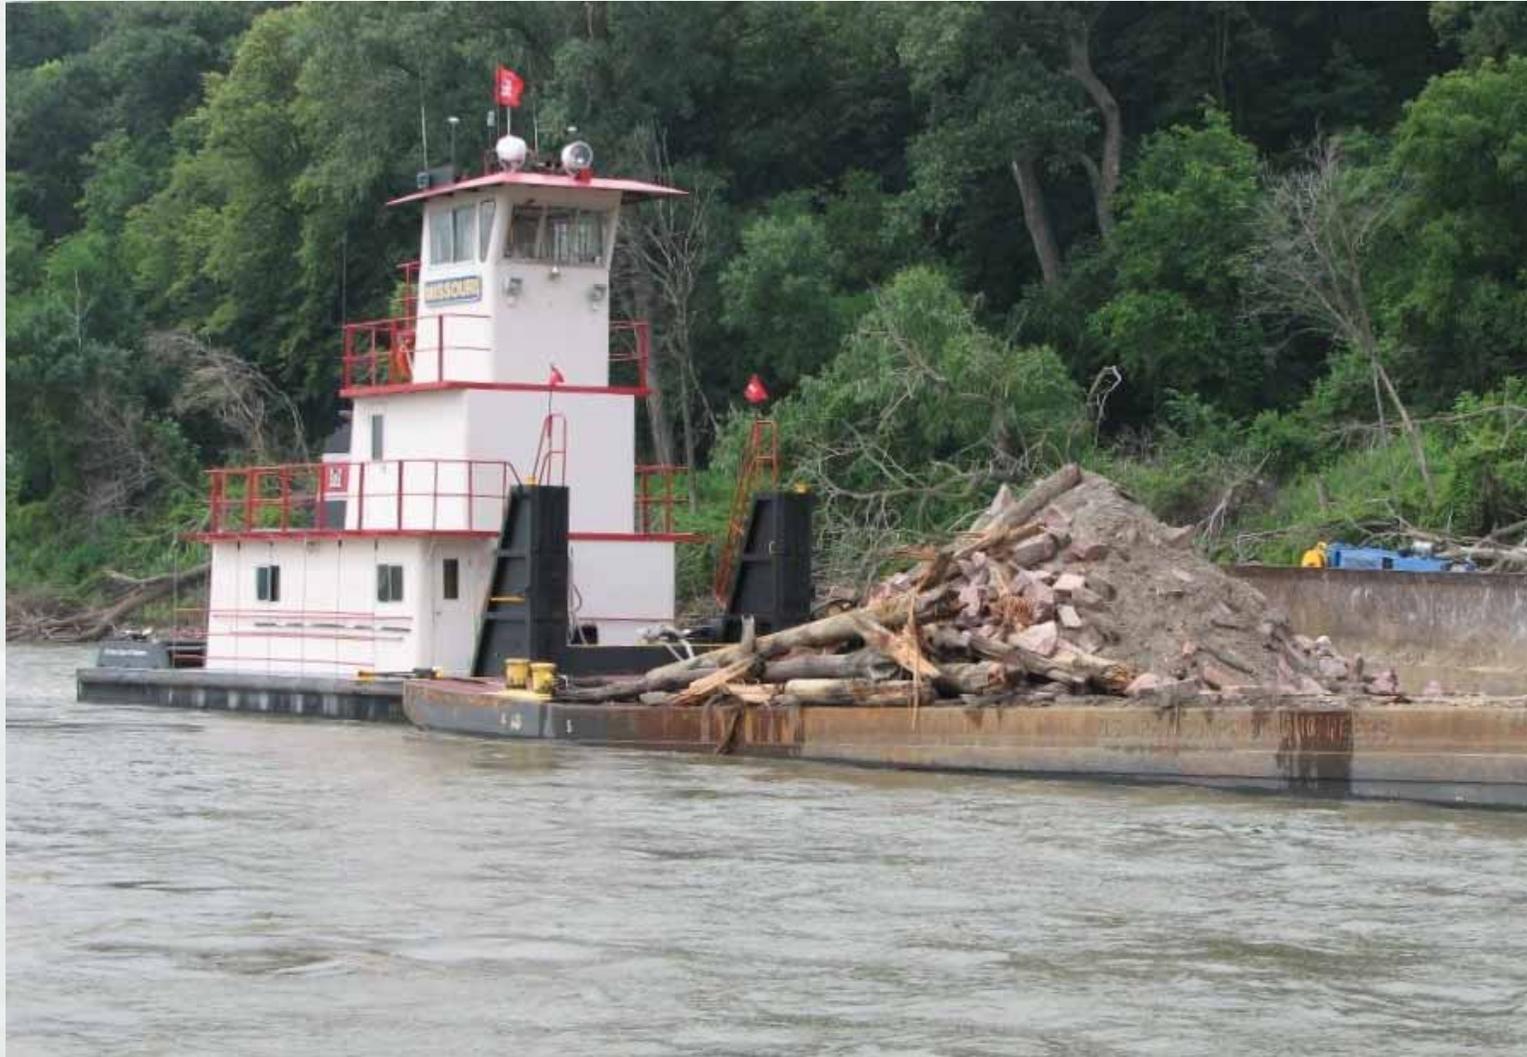
M/V Missouri Historic Structure Degradation

July 2014

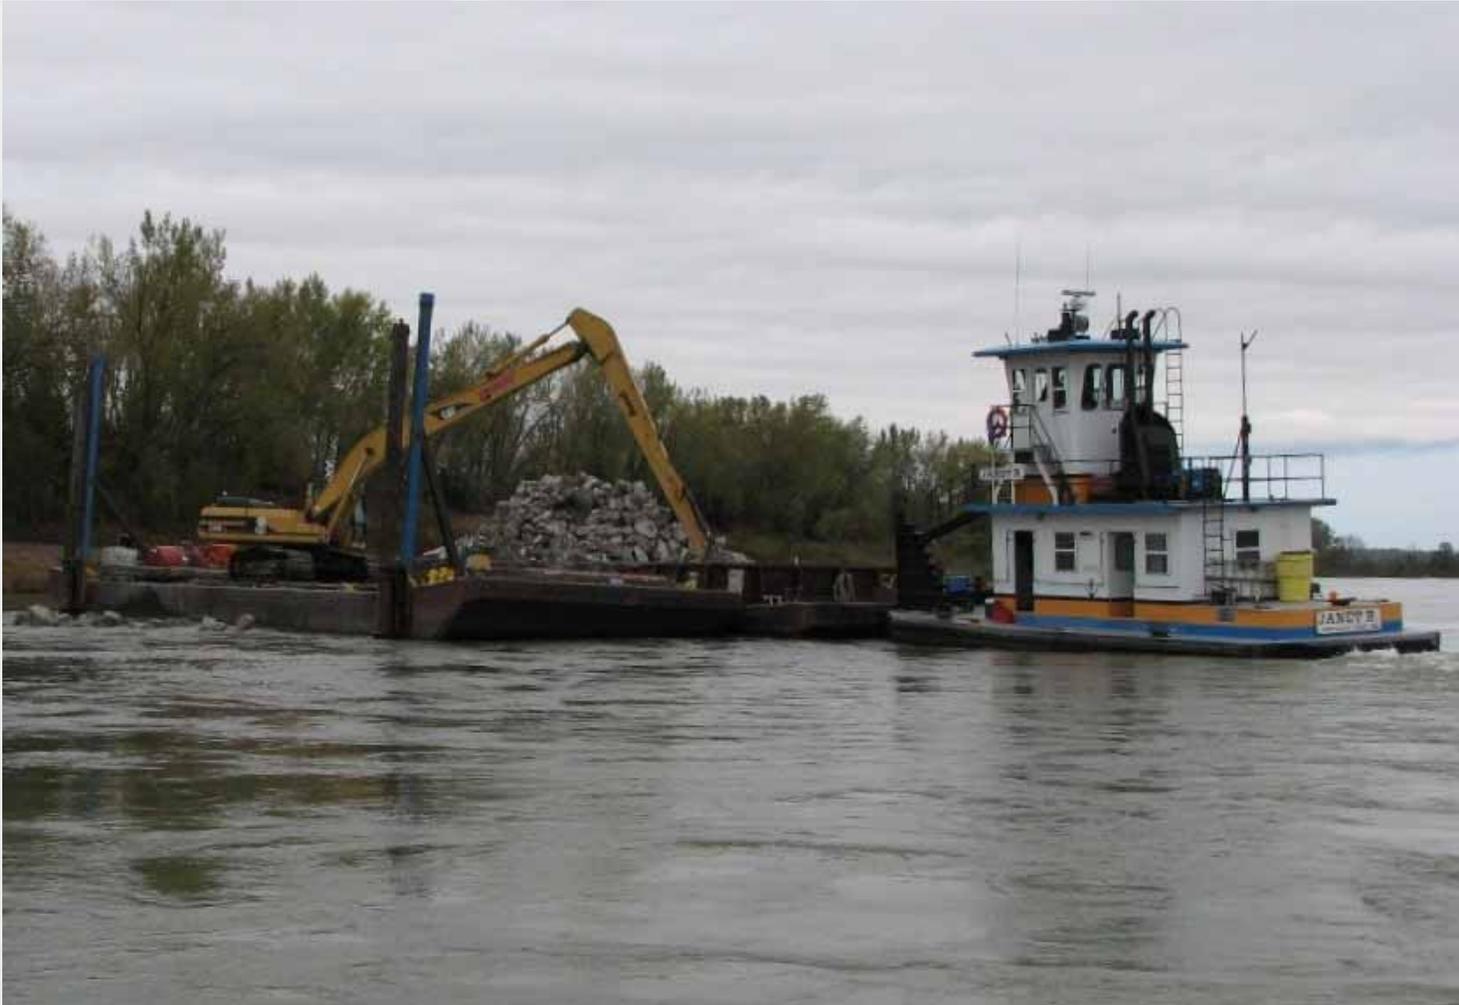
BSNP Contract Repair

Glovers Point Bend – October 2014

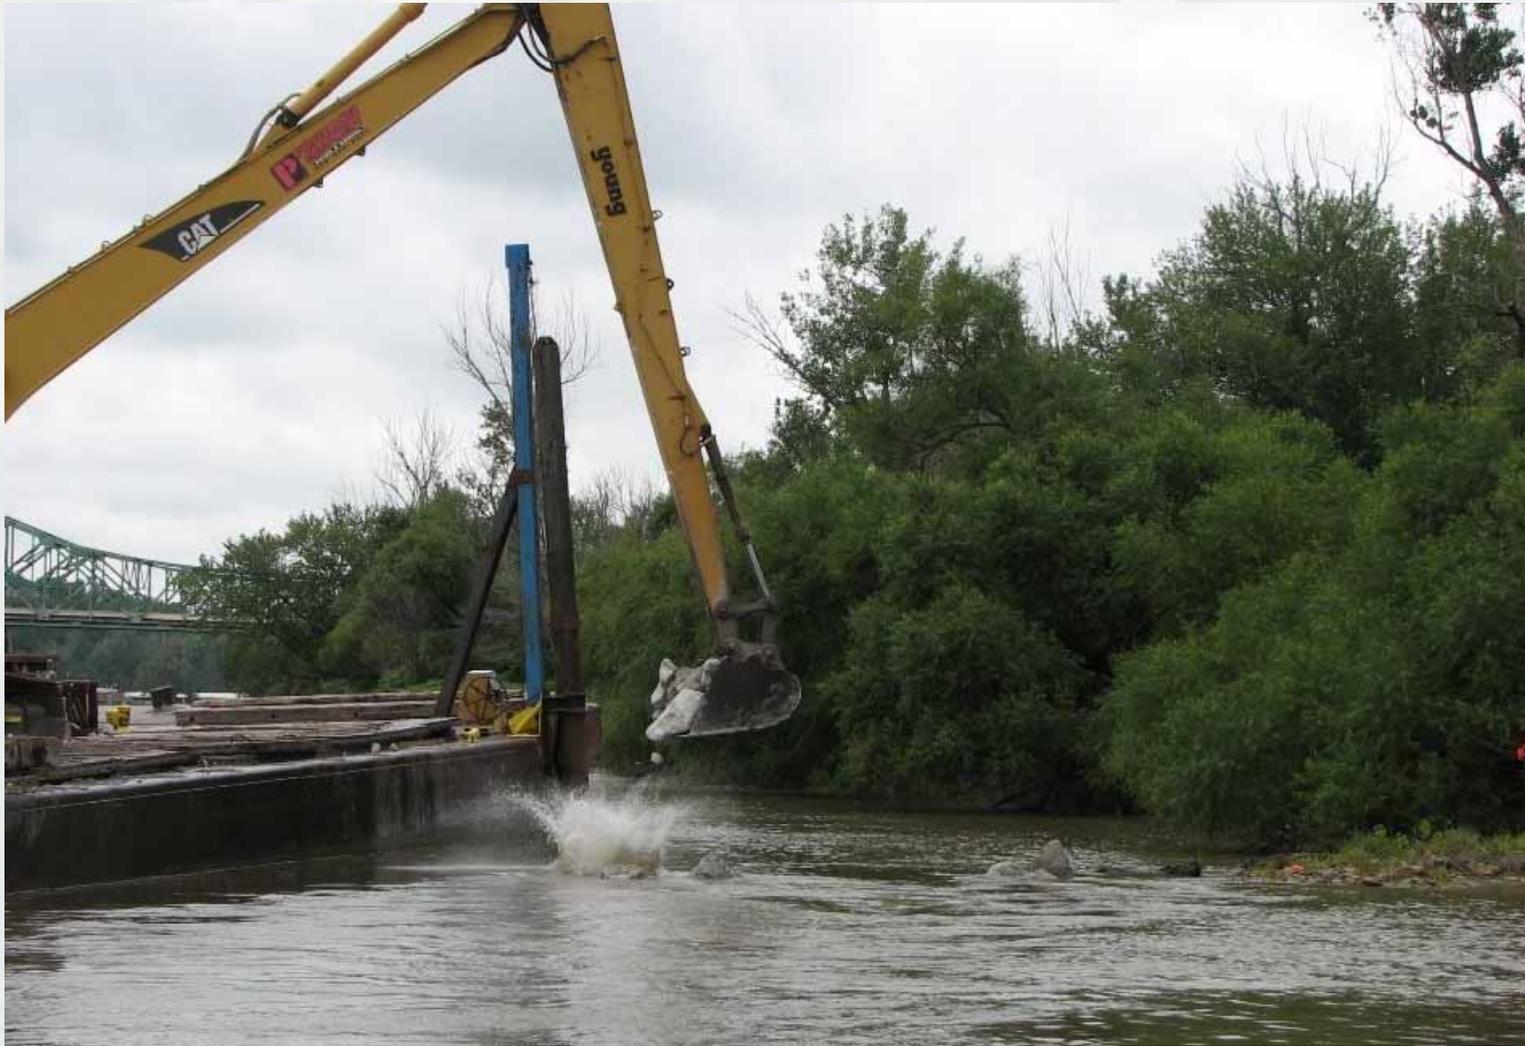
BSNP Contract Repair

Florence Bend – September 2014

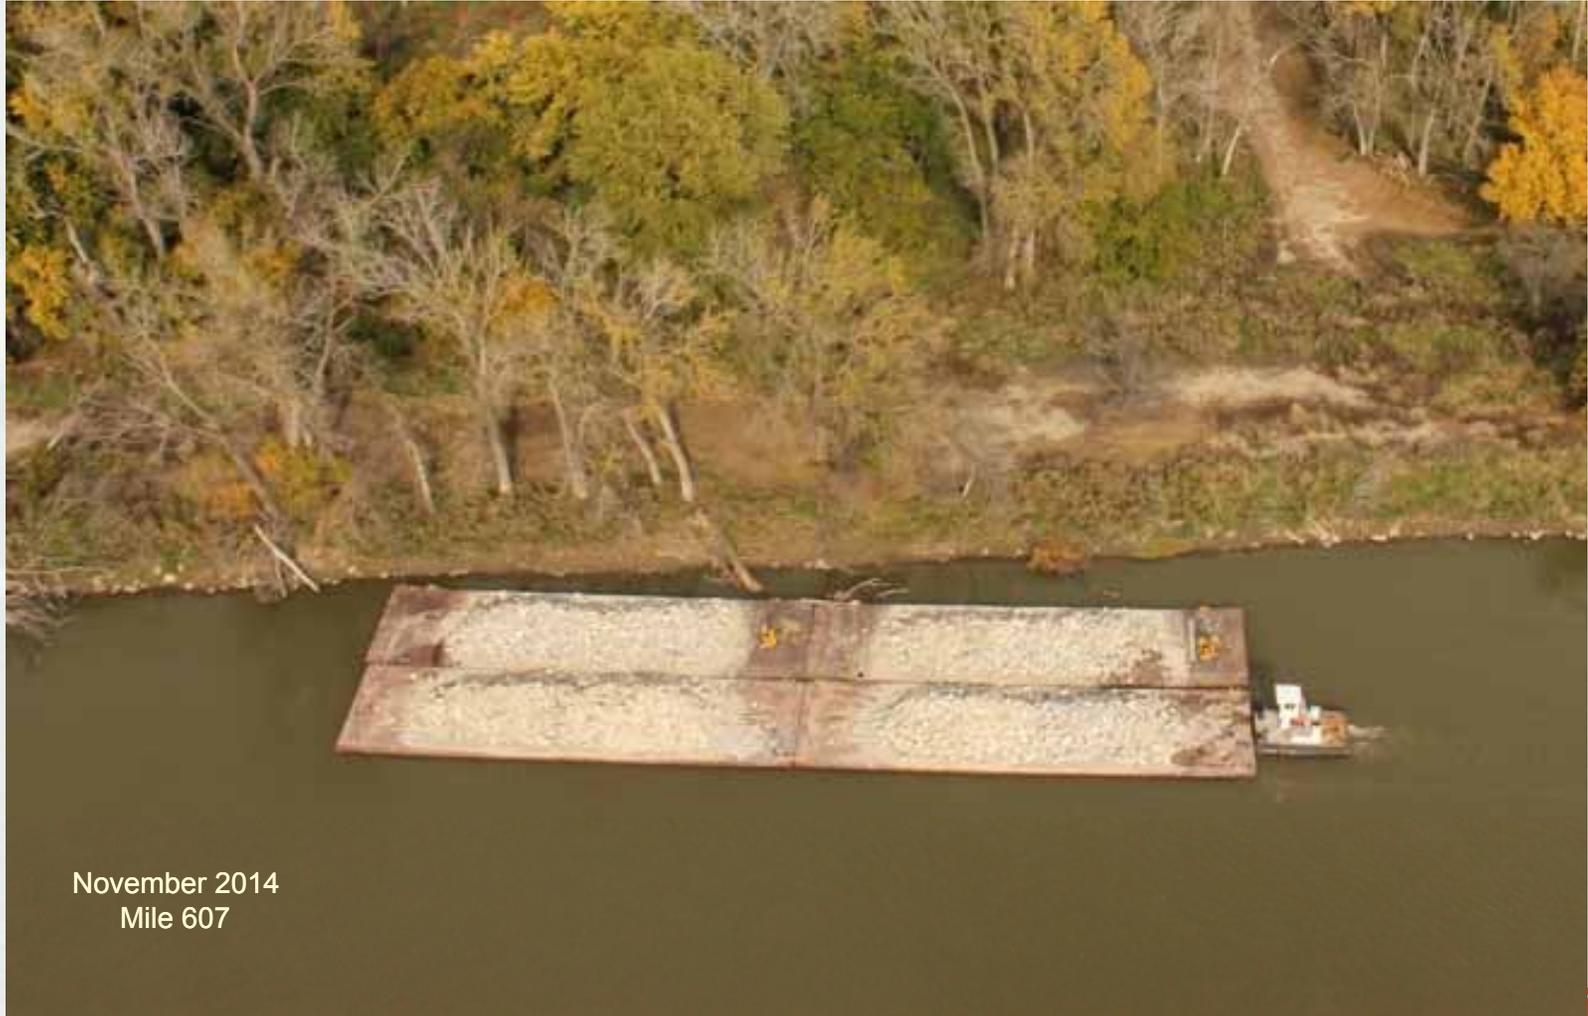
M/V Sondra Rene Pushing Rock for Revetment Repairs in Manawa Bend

November 2014
Mile 607
